Contributions to the theory and practice of rehabilitation during exploitation of reinforced concrete structures. Part II-Case Study

Next, is presented the analysis of the rehabilitation during exploitation of an technological trestle from Azomureş Târgu Mureş platform, rehabilitation done according to the principles stated above.[1]

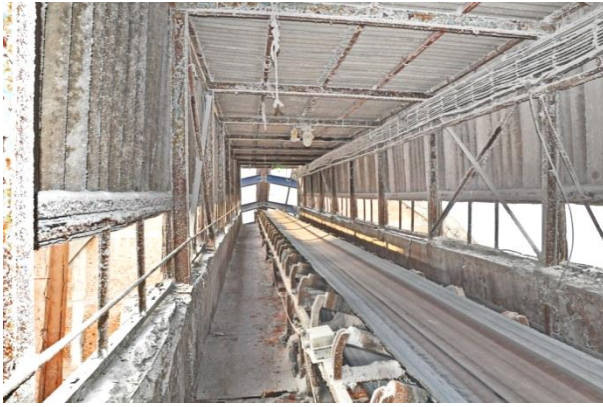
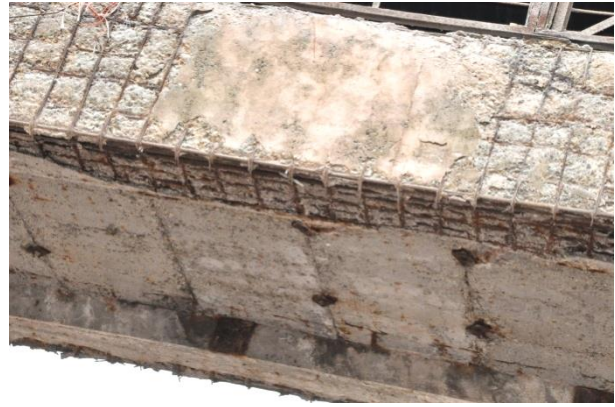
Technical condition of load bearing structure: technical condition of the trestle structure, before consolidation, was characterized by the existence of an advanced process of concrete and reinforcement degradation that significantly affected the overall strength and stability of the construction.

The reinforcement concrete covering layer was heavily damaged, up to the point of separation or isolation of the longitudinal and transversal reinforcement. The phenomenon was present at the bottom of the trestle prefabricated beams (in some areas also on the sides of the beams), it was also present at the supporting pillars of the trestle. The longitudinal reinforcement was corroded, with varying degrees of damage also transversal reinforcement. The lower part of the stockade prefabricated plates showed a lower degree of degradation. It was affected by corrosion also the supporting structure of the roof cover and side closures.

Photo 1a, 1b. Overview of the reinforced concrete trestle - initial situation

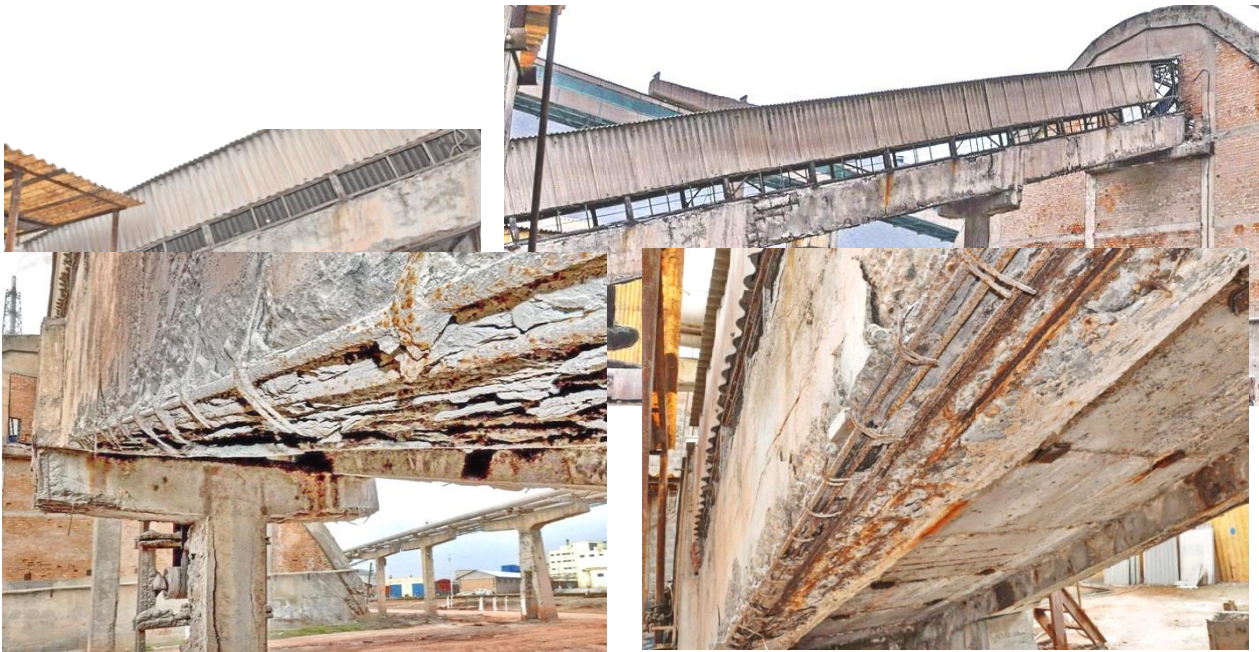
Photo 2. Initial technical condition of trestle concrete elements. a, b, c, d: Concrete corrosion, beams reinforcement; e: Technical state of the supporting console

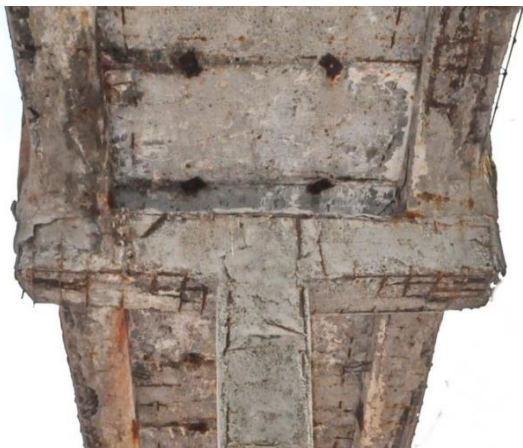
Photo 3. Execution of the rehabilitation works

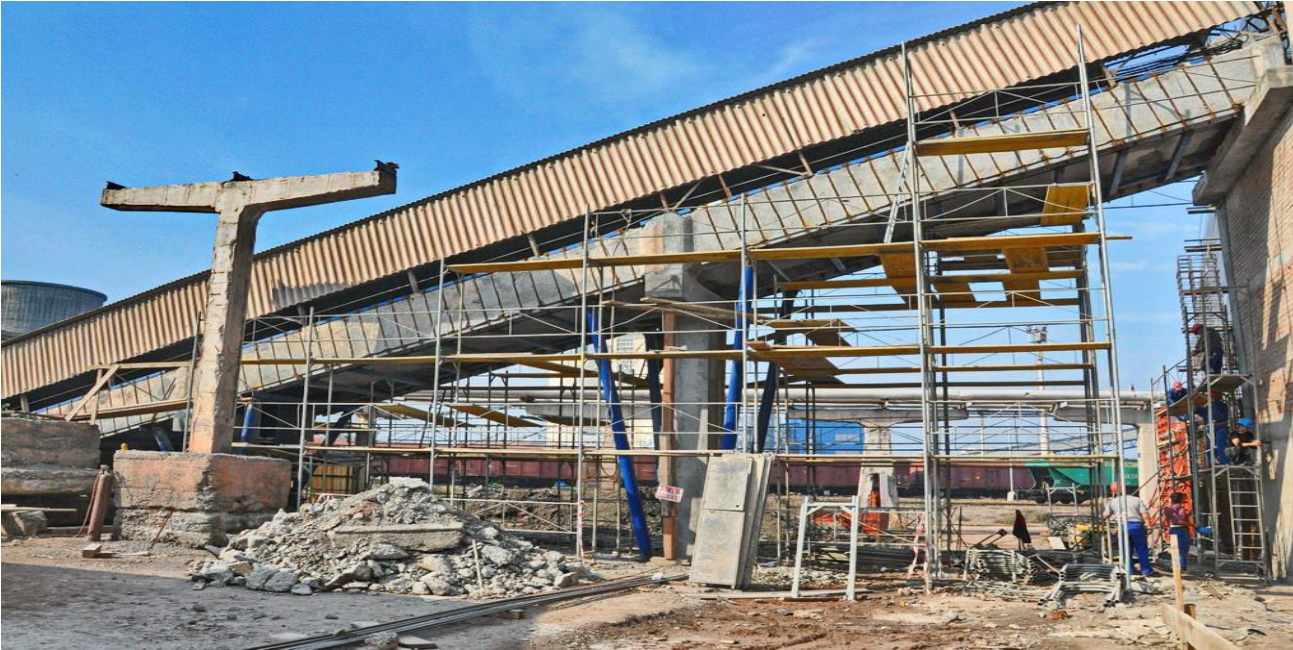
Figure. 4. Consolidation solution for trestle assembly
a. Side view
b. Section and rehabilitation solution for pillars

Resting of the beams on the pillars is ensured by the means of 4 pipe steel profiles $\phi 219 \times 8$ mm resting, through a metallic base on a bearing box of reinforced concrete with a height of 40 cm made on the top of the previous foundation. This avoids transmitting of the trestle actions to the foundation through the degraded pillars, their rehabilitation being difficult during exploitation. Anchoring of the metal base into the previous foundation was made with metallic anchors $\phi 25$ fixed with resin in $\phi 32$ holes drilled in the upper surface of the foundation.

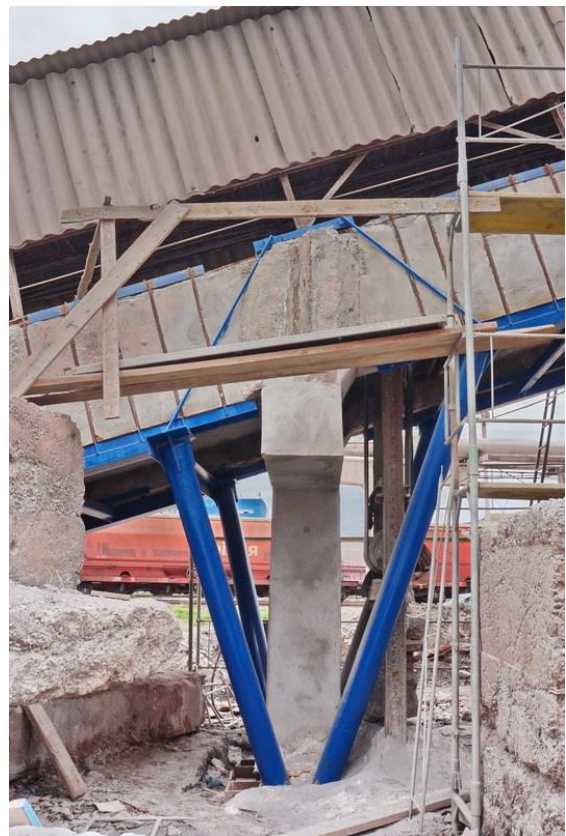
Photo 4. Same as in Fig. 5 – design detail

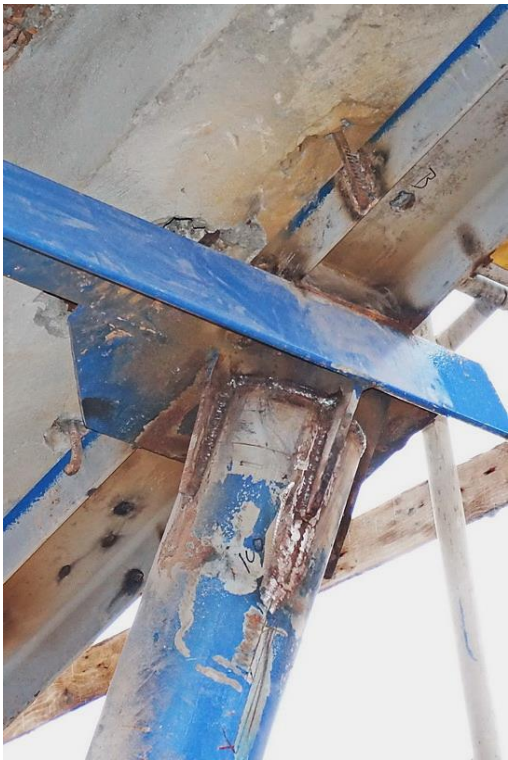
Photo 5. The same as in Fig. 7, execution

Photo 7. The situation after protection by painting

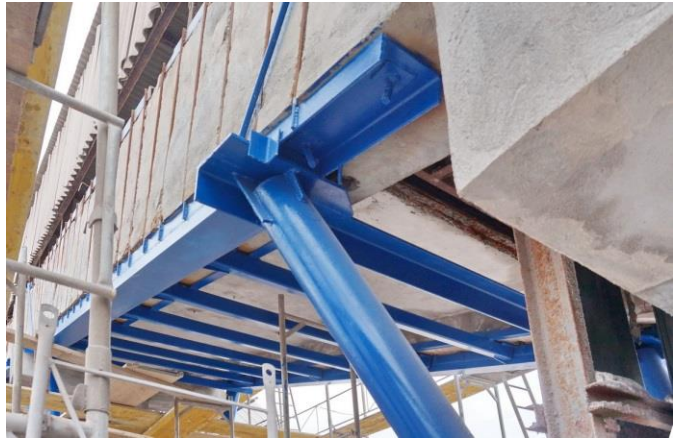
Photo 6. Execution details

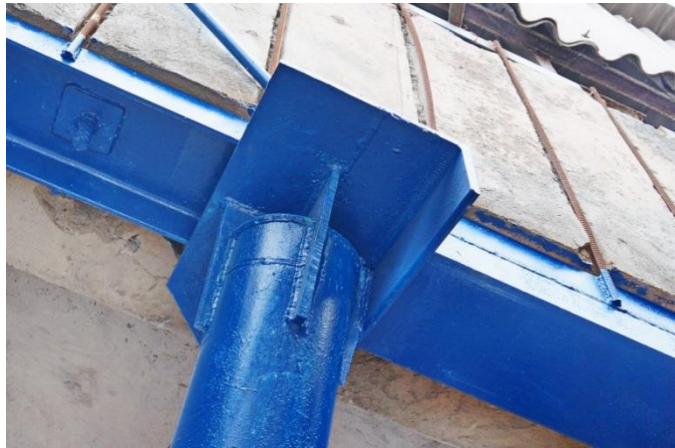
Trestle consolidation assembly
Pillar base section
scale 1:50

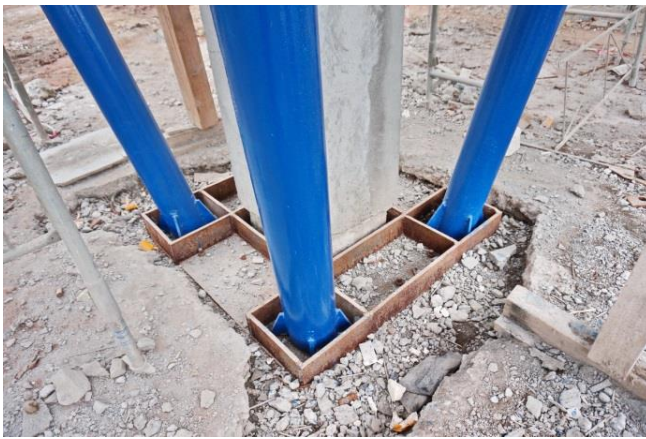
Photo 8. Execution of the system to support trestle on the foundation

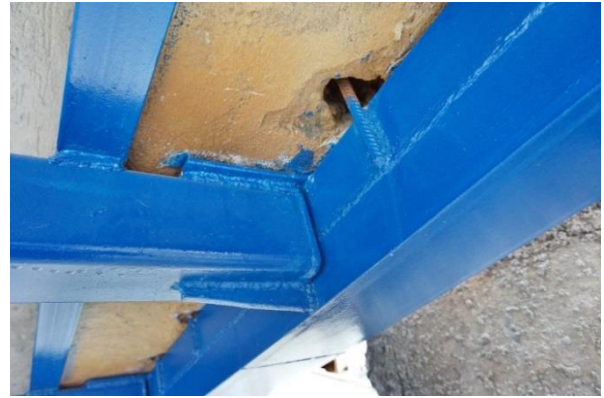
Photo 9. Execution of the beams consolidation

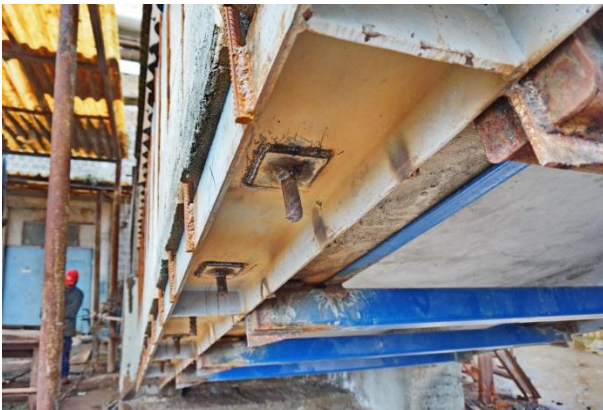
Photo 10. The same as in Photo 9, connectors view

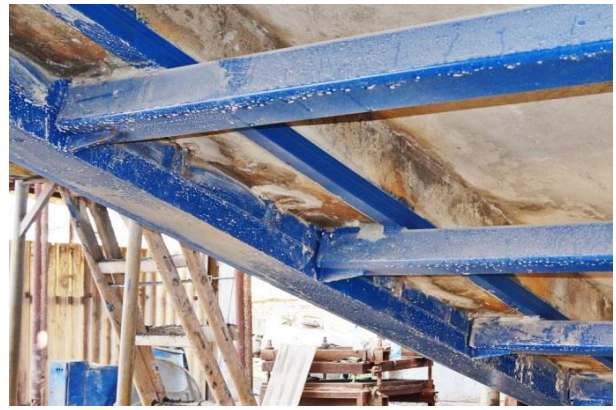
Photo 11. The same as in Photo 10, overview

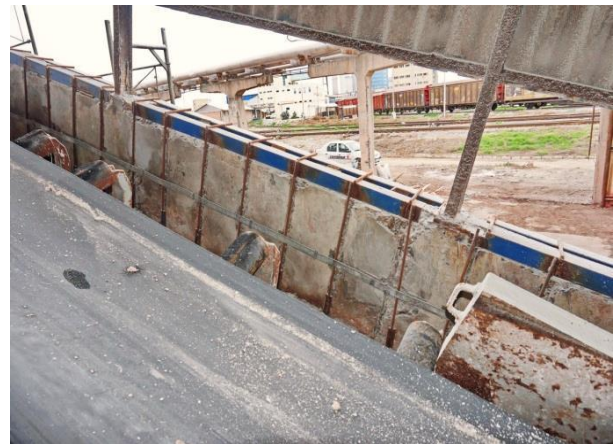
Photo 13. The same as in Photo 12

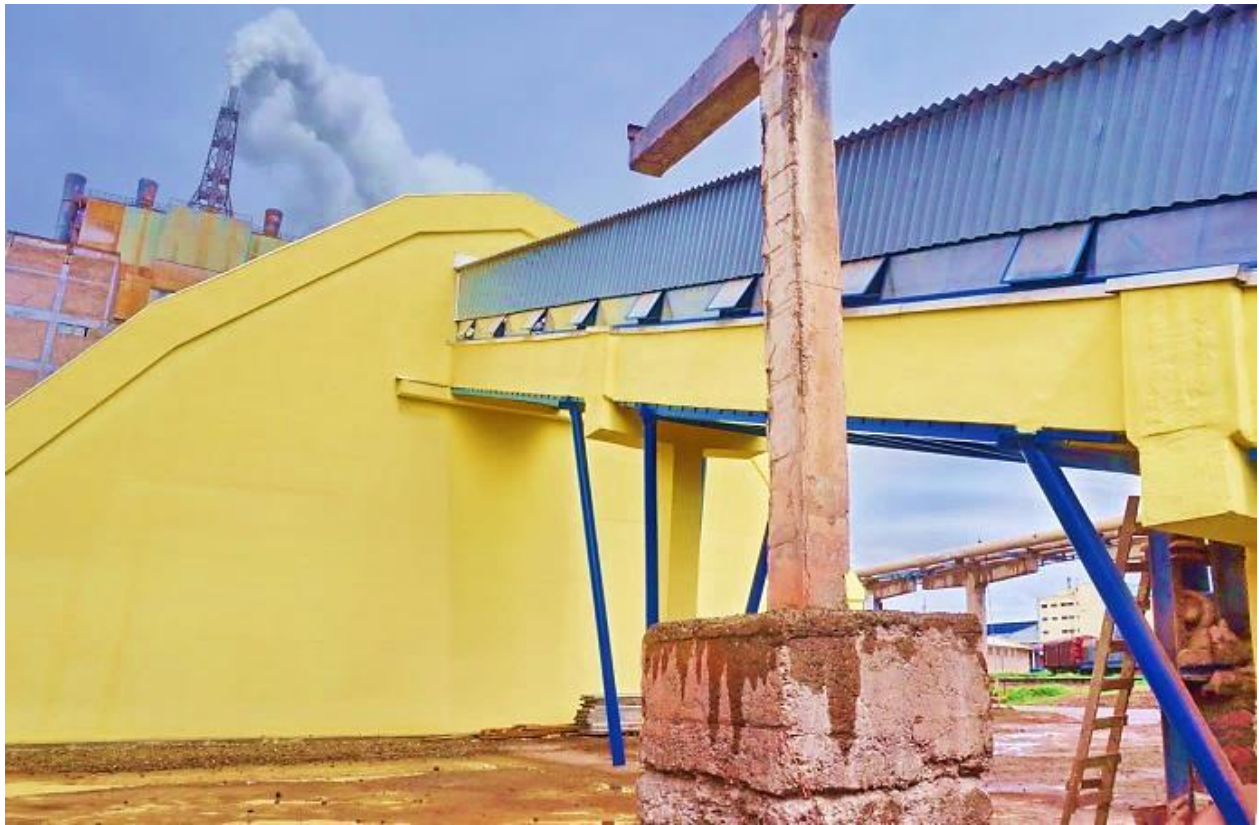
Photo 14. Post rehabilitation trestle

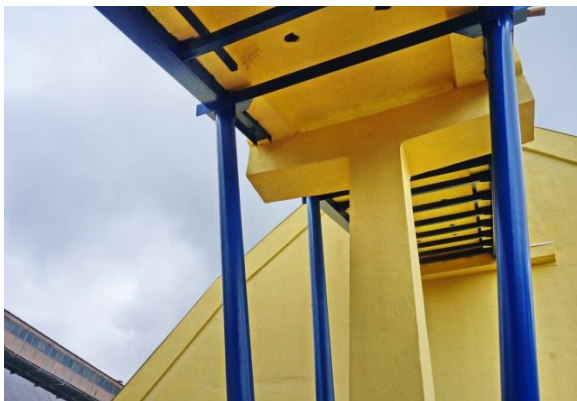
Photo 15. View of the rehabilitated trestle in the pillar area

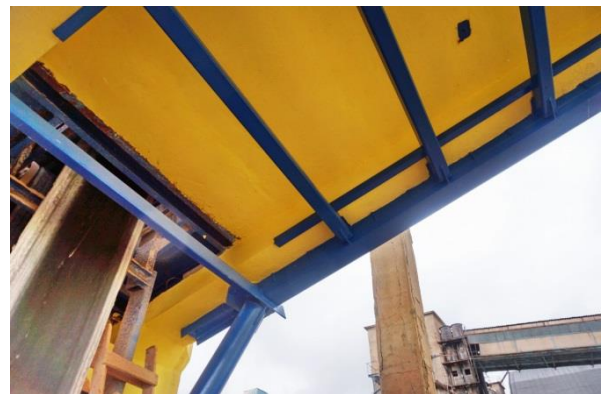
Photo 16. View of the rehabilitate trestle near the conveyor belt stretcher
